Upper Frio River Basin Bioassessment: Dry Frio and Frio Rivers in
Real and Uvalde Counties, Texas

River Studies Report No. 23

Inland Fisheries Division
Texas Parks and Wildlife Department
Austin, Texas

April 2015

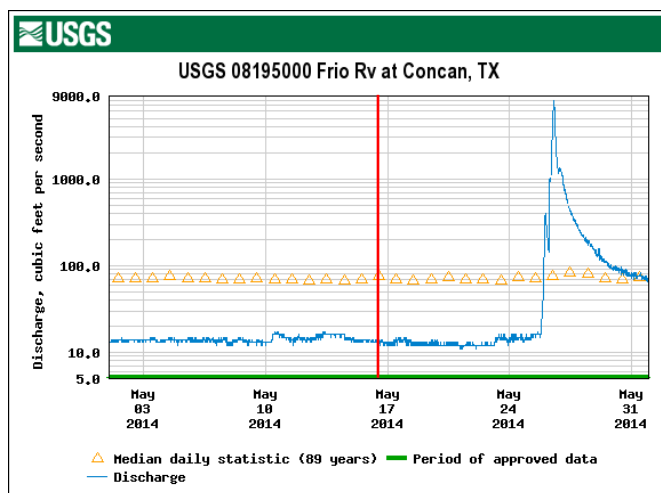
Figure 3 (top): Frio River discharge at Concan, Texas for the period of May 1-31, 2014 provided by USGS. The red line indicates the date of the bioassessment, May 16, 2014.

Water Quantity: During the week of sampling, drought maps produced by the U.S. Drought Monitor showed that Real and Uvalde counties were in severe to exceptional drought conditions (USDM 2014). This was reflected in the condition of the Frio River, which according to the nearest United States Geologic Survey (USGS) gage, located approximately 9 miles downstream of Site A (Figure 1), was flowing at only 14 cubic feet per second (cfs) (Figure 3). USGS reports this flow as 20% of the historical daily median flow (Figure 3); however, this low flow is consistent with the recent flow record (Figure 4). The USGS gage on the Dry Frio River, located approximately 7.5 miles downstream of Site D, showed that the flow during sampling was less than 1 cfs or 7% of the historical daily mean flow (Figure 5).

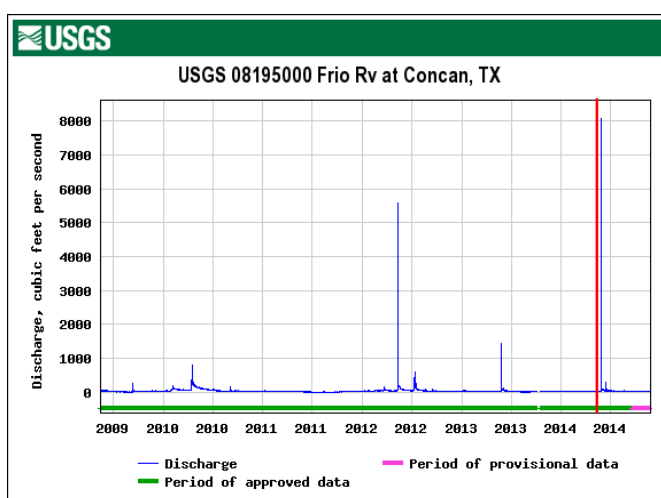
Figure 4 (middle): Frio River discharge at Concan, Texas for the period of May 2009 – November 2014 provided by USGS. The red line indicates the date of the bioassessment, May 16, 2014.

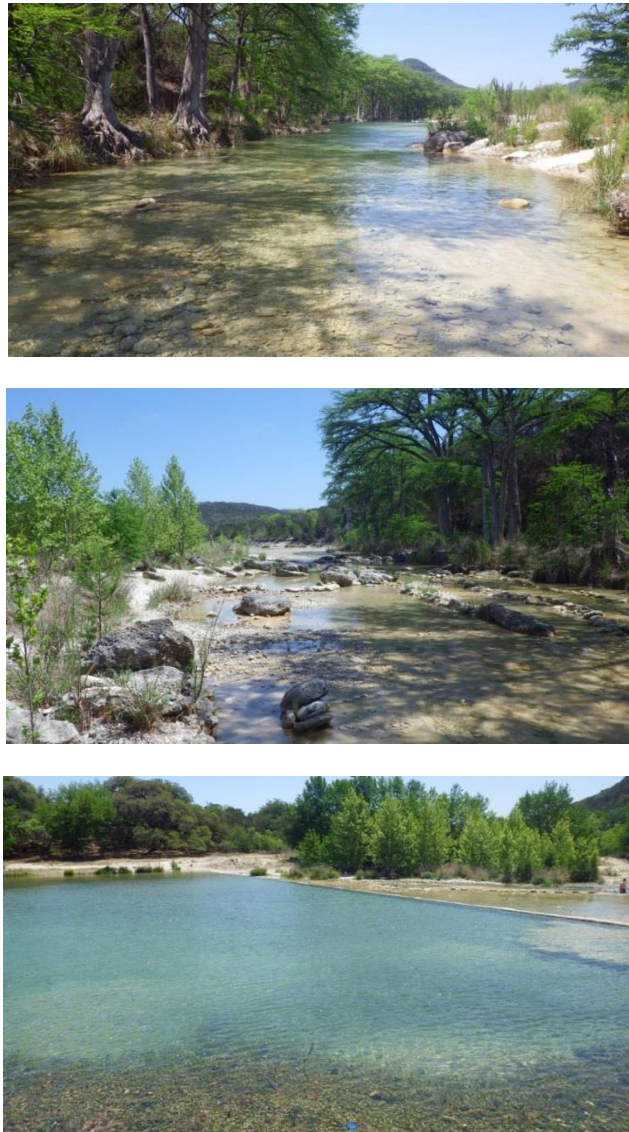
Habitat Quality: The upper Frio River (Sites A and B) is dominated by shallow water habitats over limestone bedrock and gravel substrates (Figure 6). Habitat quality was directly assessed at Site A using the habitat quality index score (Table 1; TCEQ 2007). Overall this reach received a high habitat quality index score of 21. Riparian buffer and aesthetics of the reach scored low due to development and human impacts, such as the high number of foot trails cutting through the riparian corridor to the river. The mean stream depth was 0.31 m with a mean stream width of 18.6 m. Despite the low flow of the system, the functionality of mesohabitats (riffles, runs, backwaters, and pools) remained intact and received a high score. Instream cover was found in approximately 20% of the reach and was primarily boulder and large cobble. Aquatic macrophytes were present where silt had accumulated in pools. Thirty percent of the reach was shaded, primarily by large cypress trees growing along the stream bank. Most of the stream bank had little other overhanging canopy, most likely due to bedrock substrate and scouring events.

Figure 6. The upper two photographs are typical of habitat found in the Frio River, which is dominated by shallow, flowing habitats over bedrock and gravel substrates. The lower photograph shows the low-water dam on the Frio River near the downstream boundary of Garner State Park.

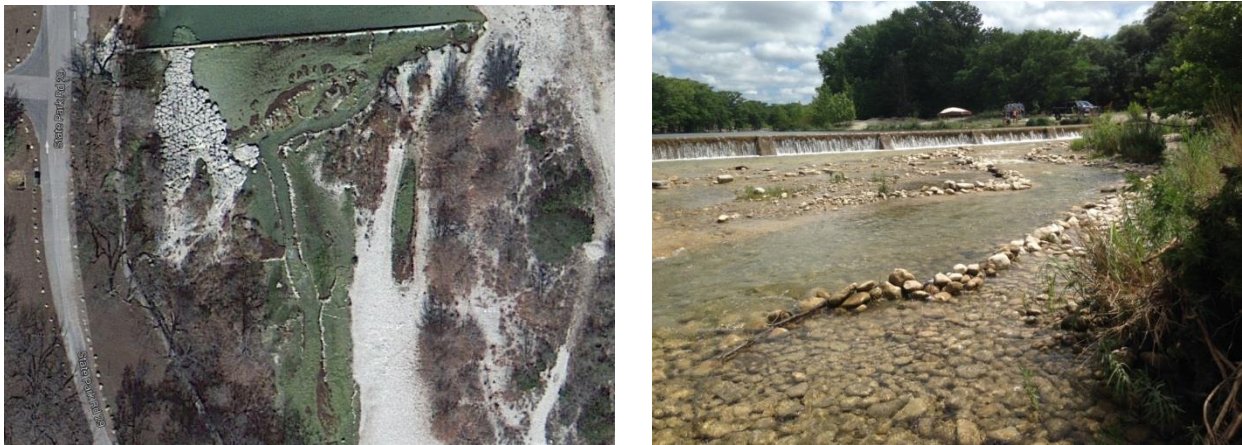
Anthropogenic changes in instream habitat were evident throughout the state park. Rock-wall structures of varying sizes had been constructed in the stream channel by park visitors, diverting flow and constricting the channel in some areas (Figure 7). Some of these structures created small pools and velocity shelters in areas that would have otherwise been run habitats. While these structures do alter the flow, the predominately bedrock bottom resists any permanent changes to stream morphology. There is no evidence that these structures are detrimental to the river or aquatic communities as long as the river is not completely dammed. It appears that some of these structures act as velocity shelters that are utilized by some fish species. While these structures do not appear permanent, a site visit on June 6, 2014, less than two weeks after an 8,000 cfs flood pulse, showed that many of the structures remained intact (Figure 7). Given the potential long-lasting effects of these structures, any that span the entire river channel and significantly alter flow should be removed.

Figure 7. Aerial imagery from 2012 (left photograph) shows the Frio River below the dam at Garner State Park with extensive man-made rock walls diverting flow within the streambed. The right image was taken in June 2014, less than two weeks after an 8,000 cfs flood pulse moved through the system. The rock walls remained largely intact after this flood event.

Man-made rock structures within the stream bed that divert flow, while semi-permanent, are likely not a concern unless they impound a section of river and significantly alter flow. In that case it is recommended the structure be removed.

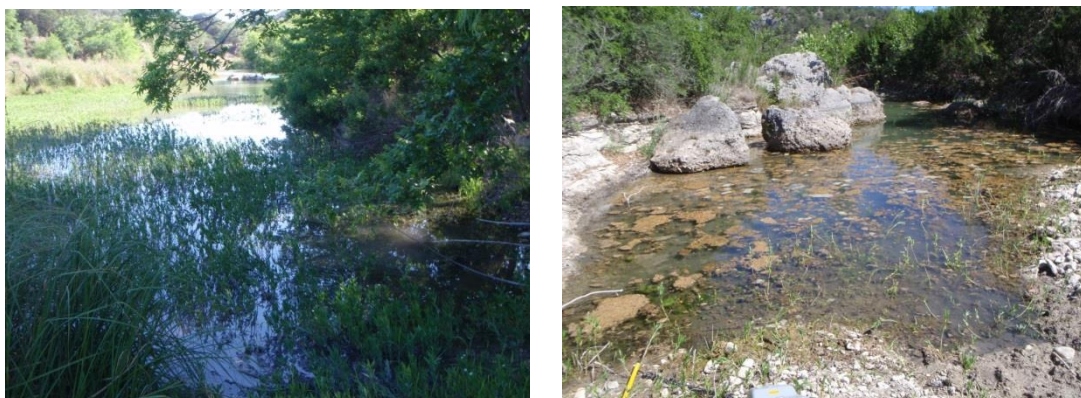
Although not quantitatively assessed, habitats on the Dry Frio River appeared to be dominated by stagnant pool habitats with little flowing water during the period of study (Figure 8). This is not surprising given the extremely low flow conditions experienced in May 2014 (Figure 5).

Figure 8. These photographs are typical of habitats found in the Dry Frio under low flow conditions, which consist of vegetated, slow moving, or stagnant pools.

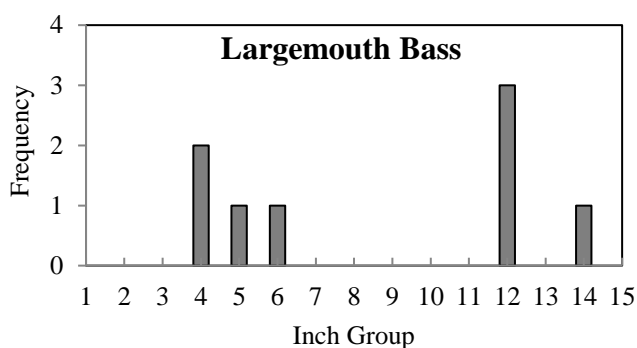
Largemouth Bass were collected from sites A and B on the Frio River and from Site D on the Dry Frio River and were the only sport fish collected. Largemouth Bass made up only 2.8% of the total catch on the Frio River and 4.1% of the catch on the Dry Frio River. Despite the low sample size, length frequency data at Site A indicates at least two year classes of Largemouth Bass were present (Figure 9). No Channel Catfish were collected despite previous stockings in this reach of the Frio River. The absence of Channel Catfish is likely due to high fishing pressure, or possible hybridization with the Headwater Catfish, which were collected in the reach. High water clarity limited electrofishing effectiveness for adult sport fish and abundance may be higher than reported.

Figure 9. Number of Largemouth Bass caught by inch group combining catch from all gear types at Site A. Largemouth Bass were also collected from sites B and D, but lengths were not recorded.

To enhance sport fishing potential for Largemouth Bass within the state park, instream cover such as large woody debris (Rosgen 1996) could be added to pools, most notably to the pool just upstream of the dam. Park staff should encourage catch-and-release angling for this species. Stocking of Channel Catfish (even for special fishing events) is not recommended within this reach of Garner State Park or in the upper Frio River, due to the high likelihood of hybridization with the imperiled Headwater Catfish. Sunfish species offer another angling opportunity. Signage or brochures could be made available to park guests to make them aware of sport fishing opportunities and to encourage catch-and-release angling.

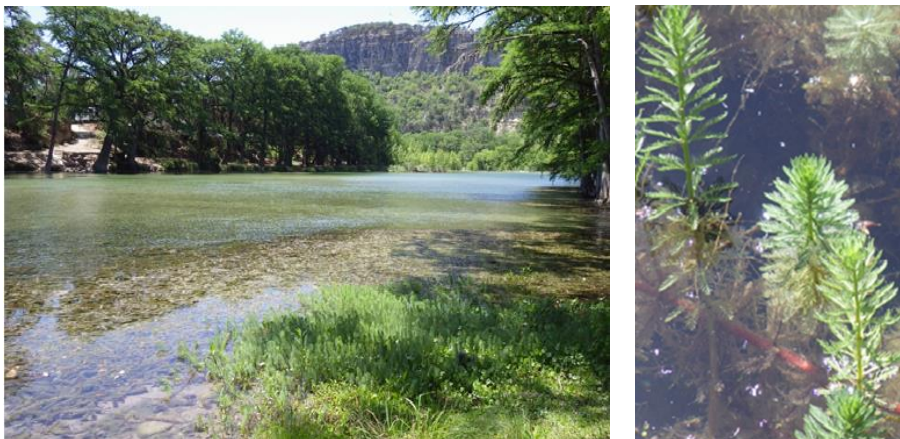
Non-Native Species: The location of non-native species found at Site A can be found in Figure 10. The only aquatic invasive plant species found within Site A was parrotfeather watermilfoil (*Myriophyllum aquaticum*) (Figure 11). While this species was limited in distribution at Site A, these sightings are the first record of this species in Uvalde County (EDDMapS 2014).

Figure 11. Photos of parrotfeather, a non-native, aquatic macrophyte, located in the Frio River at Garner State Park, May 2014.

To combat the non-native aquatic parrotfeather patches within Site A, we recommend immediate treatment with a herbicide while the infestation is limited and controllable, followed by monitoring and additional treatments should new infestations appear. Parrotfeather spreads through fragmentation, and attempts to remove infestations—mechanically or manually—often result in further spread and are not recommended. Several herbicides have proven effective for eliminating parrotfeather, including triclopyr or bispiribac-sodium (Texas A&M Agrilife Extension 2014; DiTomaso et al. 2013).

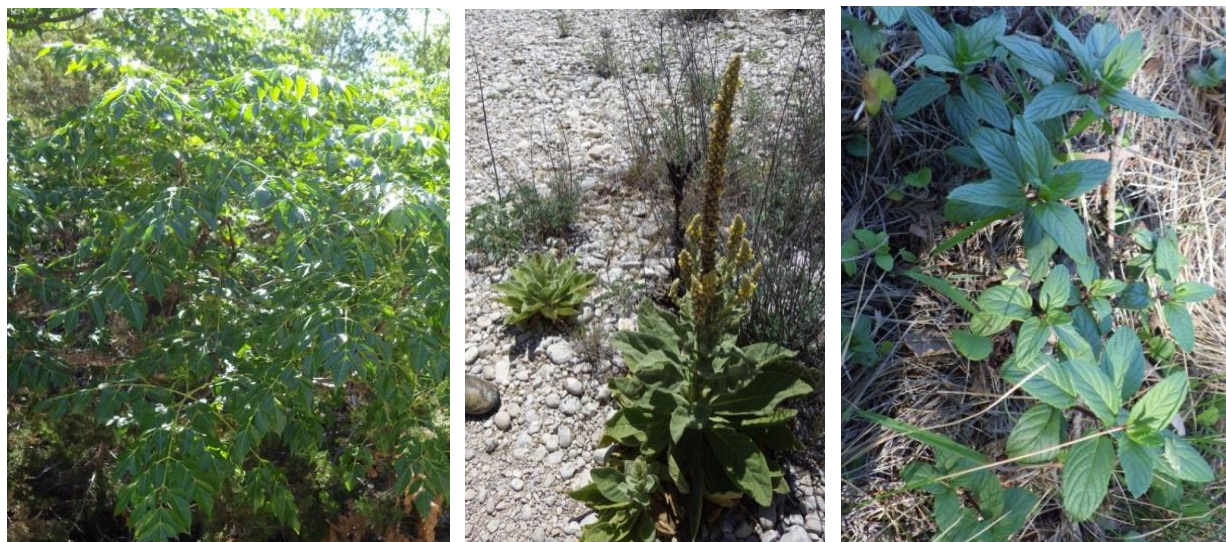
Riparian invasive plant species encountered during the survey of Site A included chinaberry (*Melia azaderach*), woolly mullein (*Verbascum thapsus*), mint (*Mentha* sp.), privet (*Ligustrum* sp.), lilac chaste tree (*Vitex agnus-castus*), and Japanese honeysuckle (*Lonicera japonica*), with chinaberry being the only widely spread of these (Figure 12). Chinaberry was found throughout Site A; however, it was only found as isolated trees and chinaberry thickets had not yet formed. Similarly, only one privet and one lilac chaste tree were mapped throughout the reach of Site A. The other non-native species encountered were present in low densities and numbers. A small bundle of dead, uprooted giant reed was found within Site A and was likely washed downstream from treated areas.

Figure 12. Photos of the most prevalent non-native species found throughout the riparian corridor of the Frio River at Garner State Park, May 2014. From left to right: Chinaberry, woolly mullein, and mint.

All riparian non-native species documented were present in low numbers, or present a low risk of spreading. The primary recommendation for all terrestrial non-native plant species is monitoring. If spreading of any of these species is detected, manual removal or the use of species-specific herbicides is recommended. While living giant reed was not found within Site A, it should be considered a priority watch species for Garner State Park due to its occurrence in other areas of the basin and potential negative impacts to natural ecosystems and public use of the park. Any stands of giant reed found in the future should be treated or removed immediately.
