# Fort Parker Lake and Fairfield Lake Water Quality Project

June 2010

Water Quality Technical Series  
WQTS-2010-03

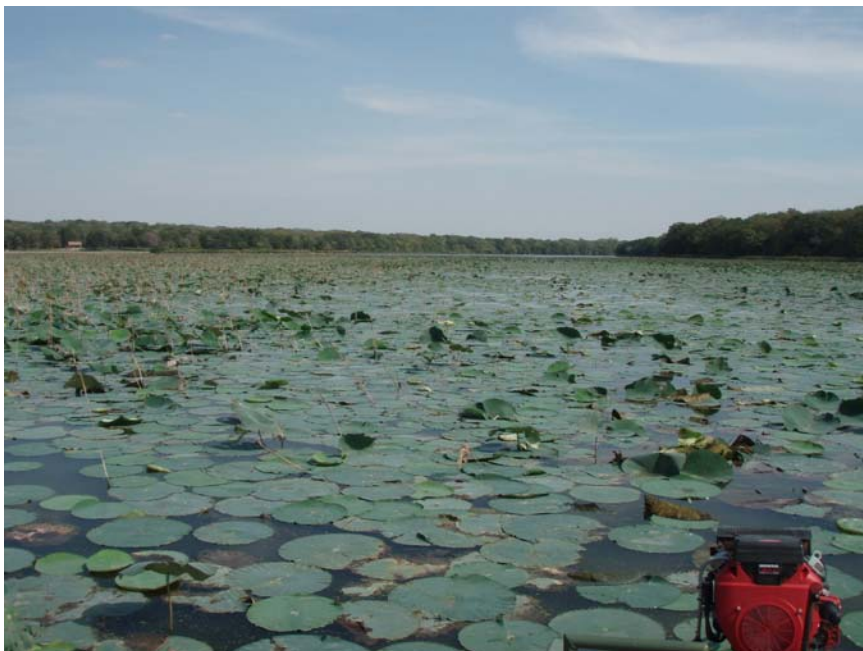
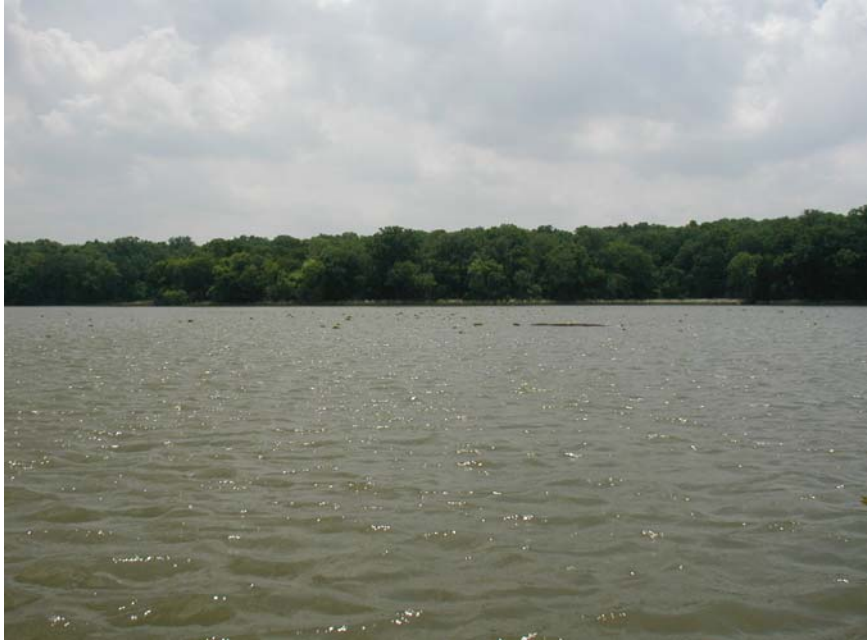
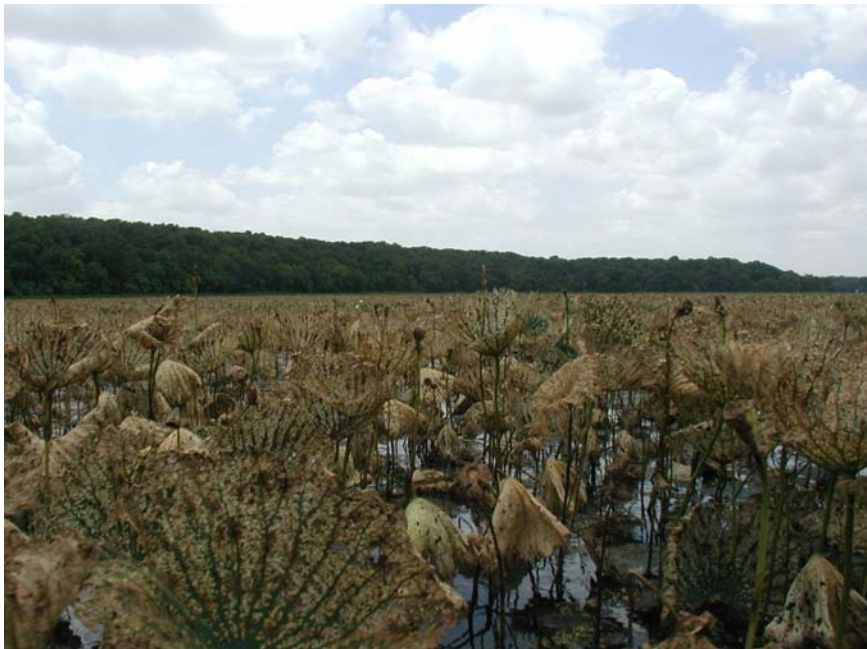
**Figure 2. Ft. Parker Lake mid-reservoir site (Oct 2006).**

**Figure 3. Ft. Parker Lake mid-reservoir site (May 2006).**

**Figure 4. Ft. Parker Lake mid-reservoir site (Jul 2006).**

Fort Parker Lake is a small impoundment on the Navasota River in the Brazos River Basin below Lake Mexia in Limestone County. The 293 ha (725 acre) reservoir was created in 1939 and is entirely within Fort Parker State Park. The reservoir is used for swimming, boating and fishing. The fishery is managed by TPWD and includes channel catfish *Ictalurus punctatus*, blue catfish *Ictalurus furcatus*, white bass *Morone chrysops*, largemouth bass *Micropterus salmoides* and white crappie *Pomoxis annularis*. The reservoir is shallow with mean depth of 1.2 m (TPWD 2007). The deepest water is found in the flooded river channel upstream of the main body (Figure 1). The upper and middle portions of the reservoir are very shallow. In 2005, this area of the reservoir had over 202 ha (500 acre) affected by American Lotus (TPWD 2007) and was often covered with floating leaves in the summer and fall (Figure 2). In the spring this area was mostly free of floating vegetation (Figure 3). During the project there was an annual infestation of insects that consumed the lotus (Figure 4), which recovered in the late summer before its

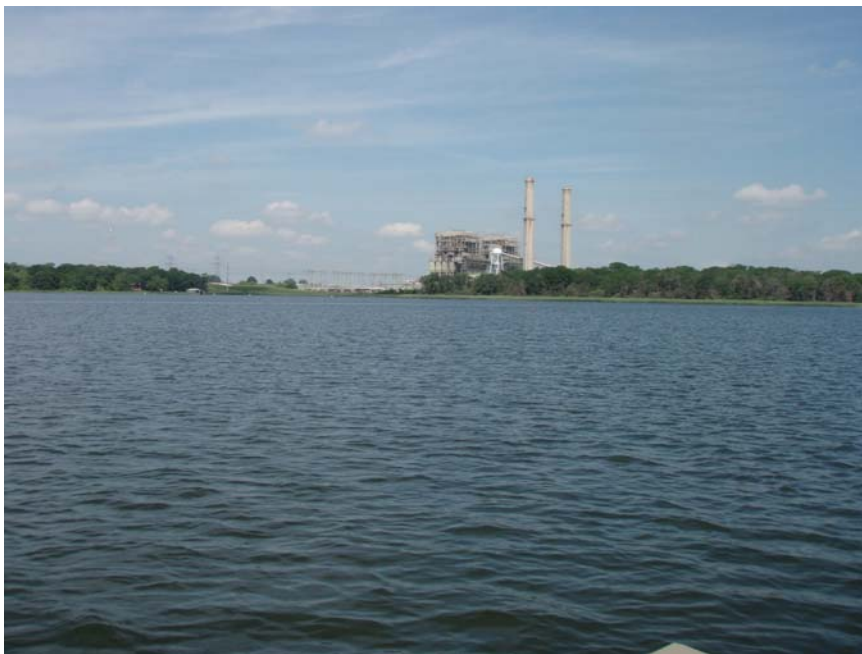
**Figure 7. Fairfield Lake site (Apr 2007).**

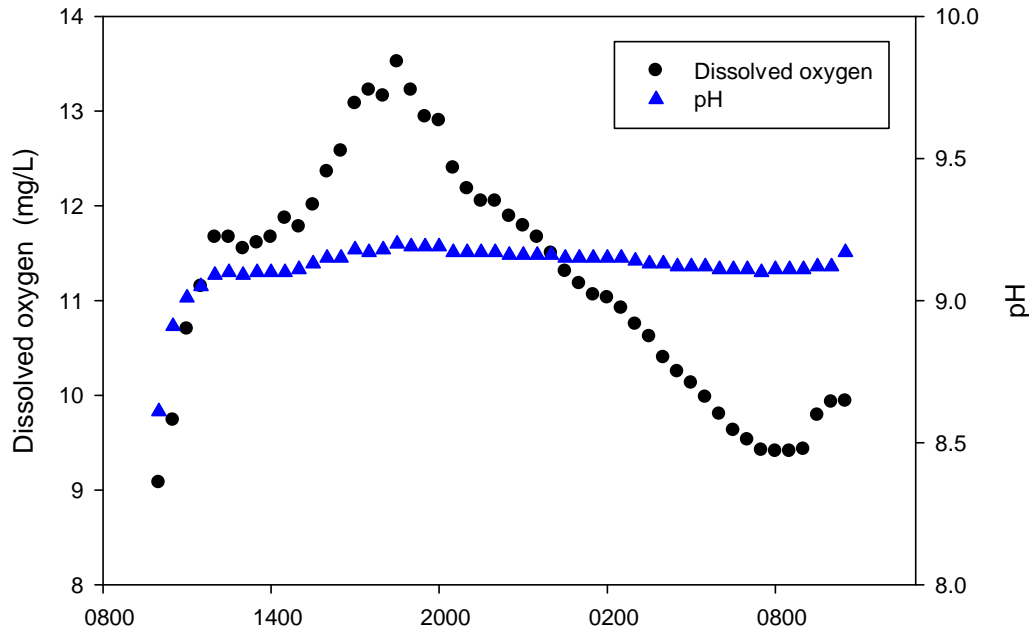
Figure 10. Fairfield Lake diel dissolved oxygen and pH measurements (16-17 Aug 2006).

Diel measurements of temperature, pH, dissolved oxygen and specific conductance were collected at Fort Parker Lake and Fairfield Lake (Table 8 and Table 9). Both exhibited diel dissolved oxygen and pH swings typical of algal photosynthesis and respiration. Dissolved oxygen, and to some extent pH, increased as daylight progressed, peaking in the late afternoon then decreasing during the evening hours and into the early morning (Figure 10). At times, diel swings in dissolved oxygen were large. Values ranged from below the minimum criterion (3.0 mg/L) to supersaturation within the same 24-hour period in August 2006 at Fort Parker Lake river channel and in June and August 2006 at Fort Parker Lake mid-reservoir. The largest of these dissolved oxygen swings was a 10.2 mg/L range between the minimum and maximum at mid-reservoir in August 2006. Fairfield Lake diel dissolved oxygen measurements never fell below the mean criterion (5.0 mg/L), and in August 2006 and September 2007 values remained above 9.0 mg/L for 24 hours. The largest swing in dissolved oxygen was in June 2006, with a range of 5.9 mg/L to 14.4 mg/L in a 24-hour period.

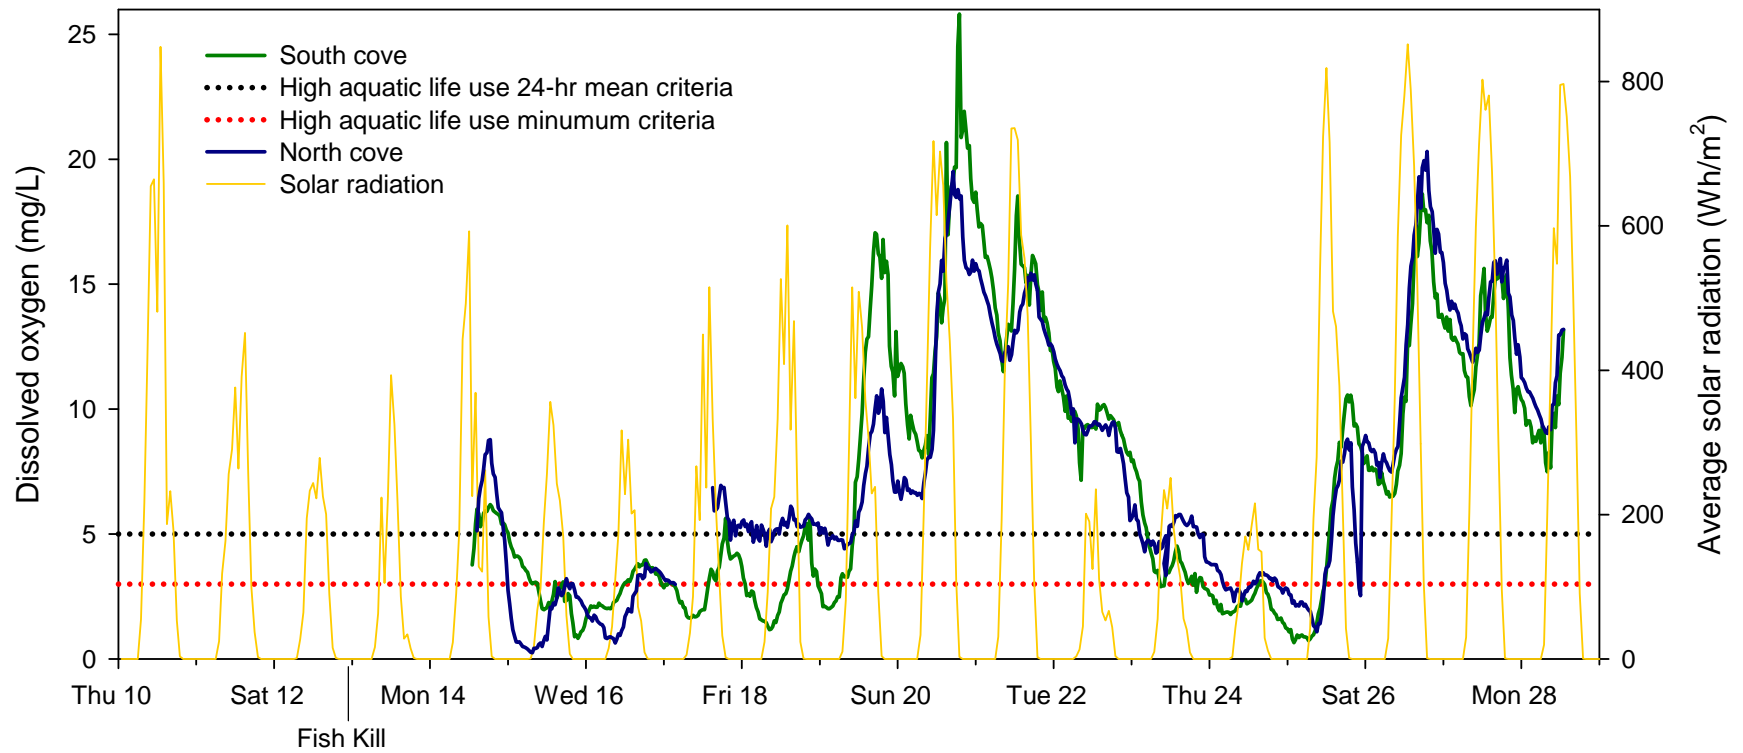
**Figure 11. Fairfield Lake diel dissolved oxygen and average hourly solar radiation data (Sep 2009). Solar radiation data from NOAA NCDC weather station in Palestine, Texas.**

Datasondes were deployed in two areas soon after the start of the September 13, 2009, fish kill. Data showed a clear diel pattern of dissolved oxygen from algal photosynthesis and respiration in both areas (Table 12). Nearly identical periods of supersaturation as well as periods of low dissolved oxygen were observed. The longest period of supersaturation in both coves was

In addition to algal processes, periods of cloudy and sunny weather have a significant influence on dissolved oxygen. Solar radiation data from a nearby weather station was examined to help interpret how fluctuations in the amount of sunlight which reaches the earth's surface affects dissolved oxygen (NOAA 2009, Figure 11). Dissolved oxygen measurements tracked the solar radiation data. Periods of cloudy weather (less solar radiation) limited algal photosynthesis, which in turn reduced the amount of dissolved oxygen measured. The inverse was observed during periods of sunny weather (more solar radiation). When the cloudy weather cleared, dissolved oxygen rebounded due to an increase in algal photosynthesis. The diel dissolved oxygen pattern observed at Fairfield Lake is an extreme example of how a combination of hypereutrophic conditions and changes in weather can impact aquatic life.
