**Habitat Renovation/Enhancement at Phantom Lake Spring,
Jeff Davis County**

**Section 6 Grant E-53 Final Report
TPWD Contract Number 173071
Habitat Renovation/Enhancement at Phantom Lake Spring,
Jeff Davis County**

Reported 28 September 2007 by
The Nature Conservancy

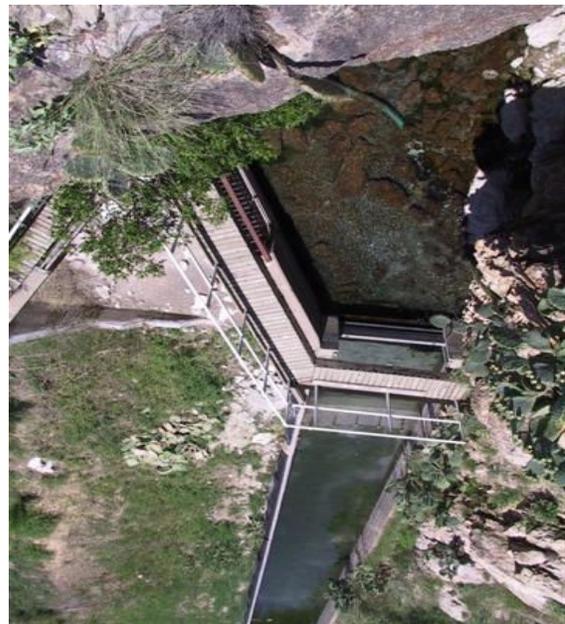
Fig. 1b – inverted to match to Fig. 1a

Figure 1a depicts the site configuration and context; figure 1b is a down-on view of the configuration from above the cave mouth looking downstream in outflow direction.

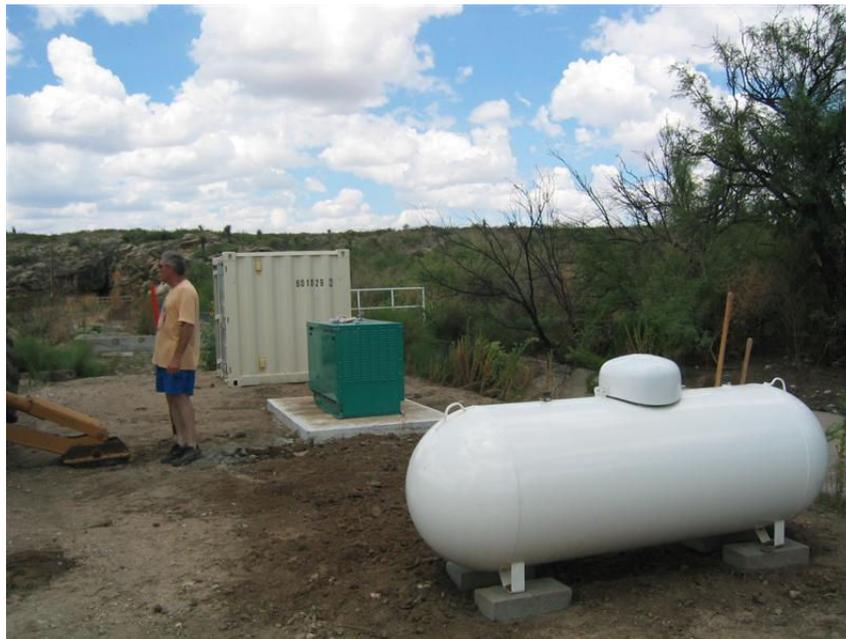
Figure 2 – 2006 Power equipment installations

Obligation 1c (habitat construction/implementation): The first two actions were by BOR tied into the project as part of the Bureau's commitment to the pump restoration and water management project. The Bureau had been accumulating necessary materials specified by the engineering analysis, and storing them at Balmorhea State Park. In the summer of 2006, BOR prepared the designated site outside of the cave mouth for the infrastructure and delivered and positioned the generator, the propane tank and modular cargo shed (Fig. 2).

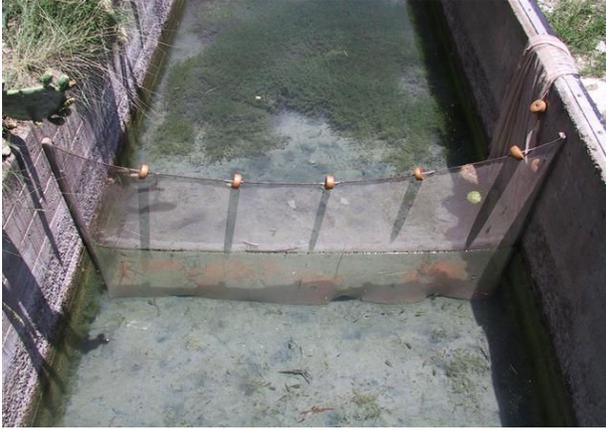
Fig. 3a – BOR netting

The next on-site action was initiated by BOR proactively in May-June 2007, to deliver additional plumbing and electrical hardware in advance and to install netting across the irrigation canal (Fig. 3a), to isolate pupfish for ease of capture and relocation back into the cave mouth pool following all of the construction and power installation actions of this project.

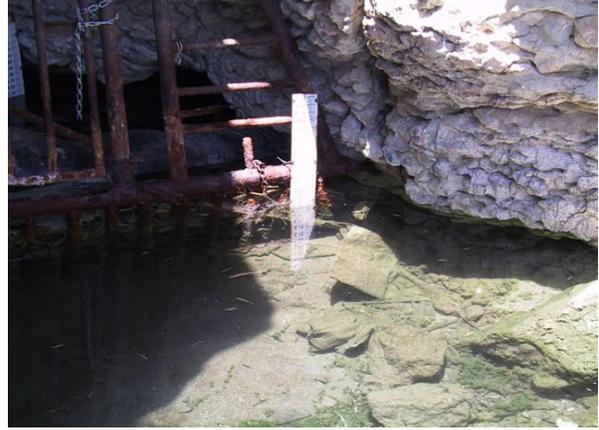
Fig. 3b – High water on 14 June 2007

Work was to commence on the subcontracted components of the project but high water discharges in May-June (Fig. 3B) precluded any installation of structures at the cave mouth, which was actually good for the rare elements but another delay to construction and other actions. Young, Karges, and a construction subcontractor met on site in late May to detail the final proposed construction aspects. The cave mouth pool volume was so high it precluded draining in preparation for constructing the forms and installing the new concrete stop-log gate.

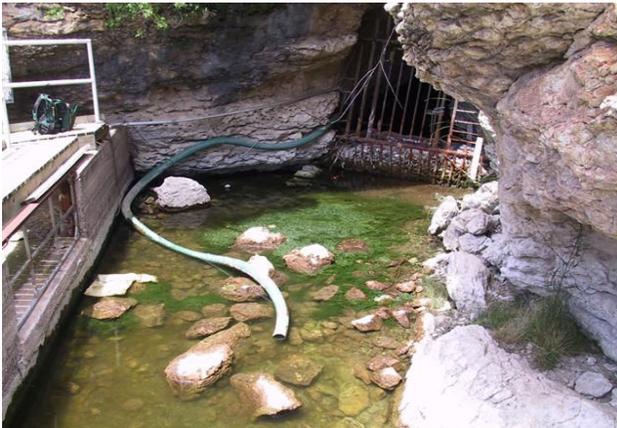
Work began in earnest in mid-July, fortunately just after the 12 July discovery that the existing pump had completely failed (Fig. 4a). The failure could have been ecologically catastrophic had the discovery timing not been so coincidental with the project team's on-site attention and attendance. Because BOR had delivered the replacement pumps and some wiring and plumbing supplies on-site, TNC was able to install a "survival" pump and aerated pipe discharge system to sustain water discharge into the cave mouth pool (Fig. 4b) and into the irrigation canal with the bulk of the pupfish population, which has persisted throughout the construction phases.

Fig. 4a - 12 July – discovery of pump failure

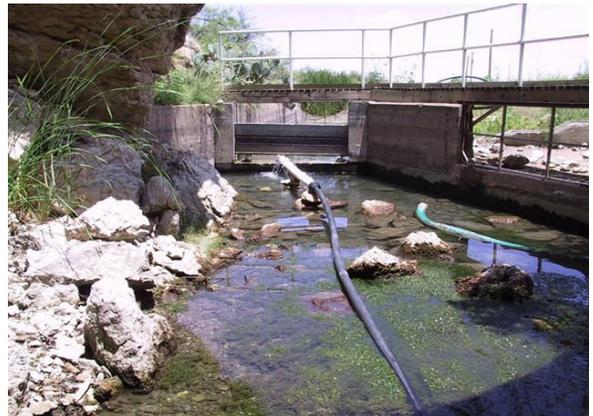
Fig. 4b – 13 July – installed survival system

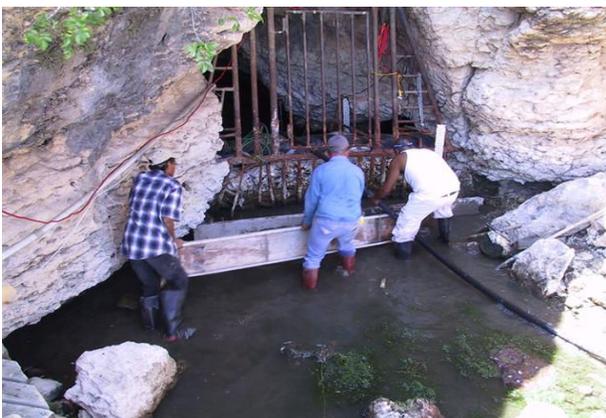
Fig. 5a – installing concrete forms

Installation of the concrete forms and pouring of the concrete for the stop-log gate at the cave mouth, just outside the gate, occurred during the week of 16-19 July under the supervision and oversight of Aspen (Mitch Young) and TNC (Karges), figures 5a&b and fig. 6.

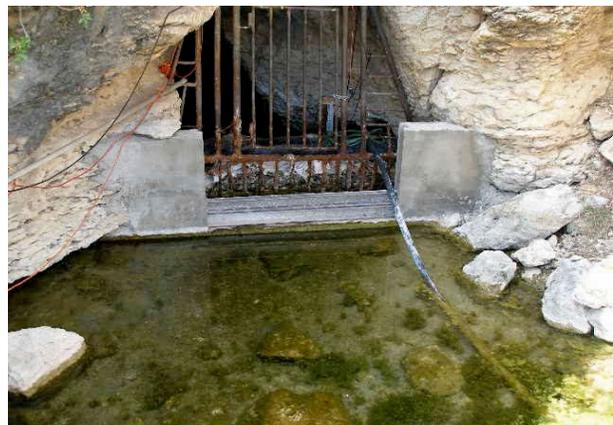
Fig. 5b – installed stop-log gate

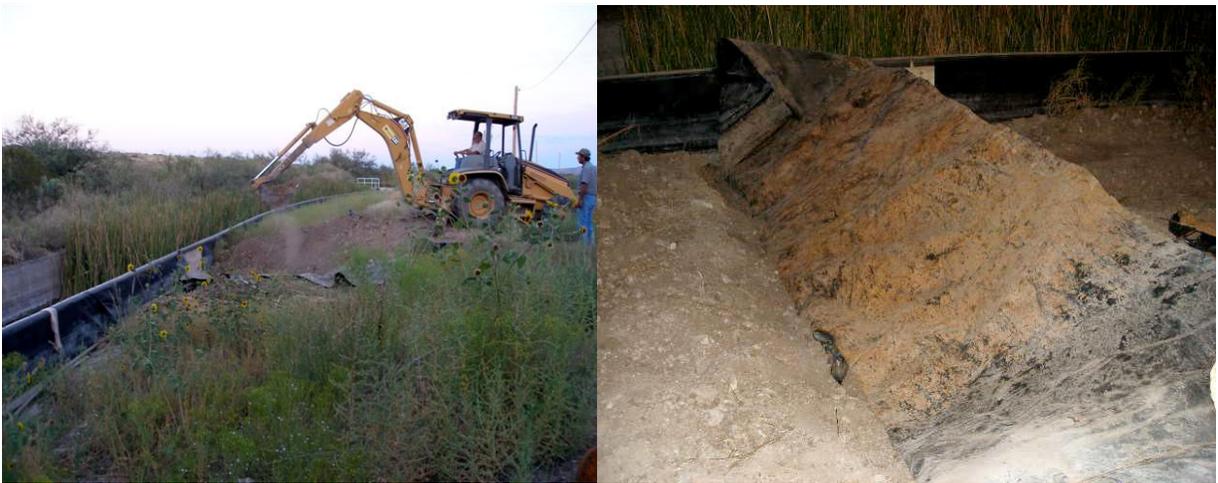
Fig. 7a & b– construction of refugium canal berm

The final on-site action as part of the obligation and implementation of the current project was the construction of the berm across the existing ‘refugium’ canal, as designed as additional pupfish habitat as part of the engineering design. This was completed under Aspen’s supervision of a construction contractor (Figs. 7a&b).
