PERFORMANCE REPORT

FEDERAL AID PROJECT F-221-M-4

2013 Fisheries Management Survey Report

McClellan Reservoir

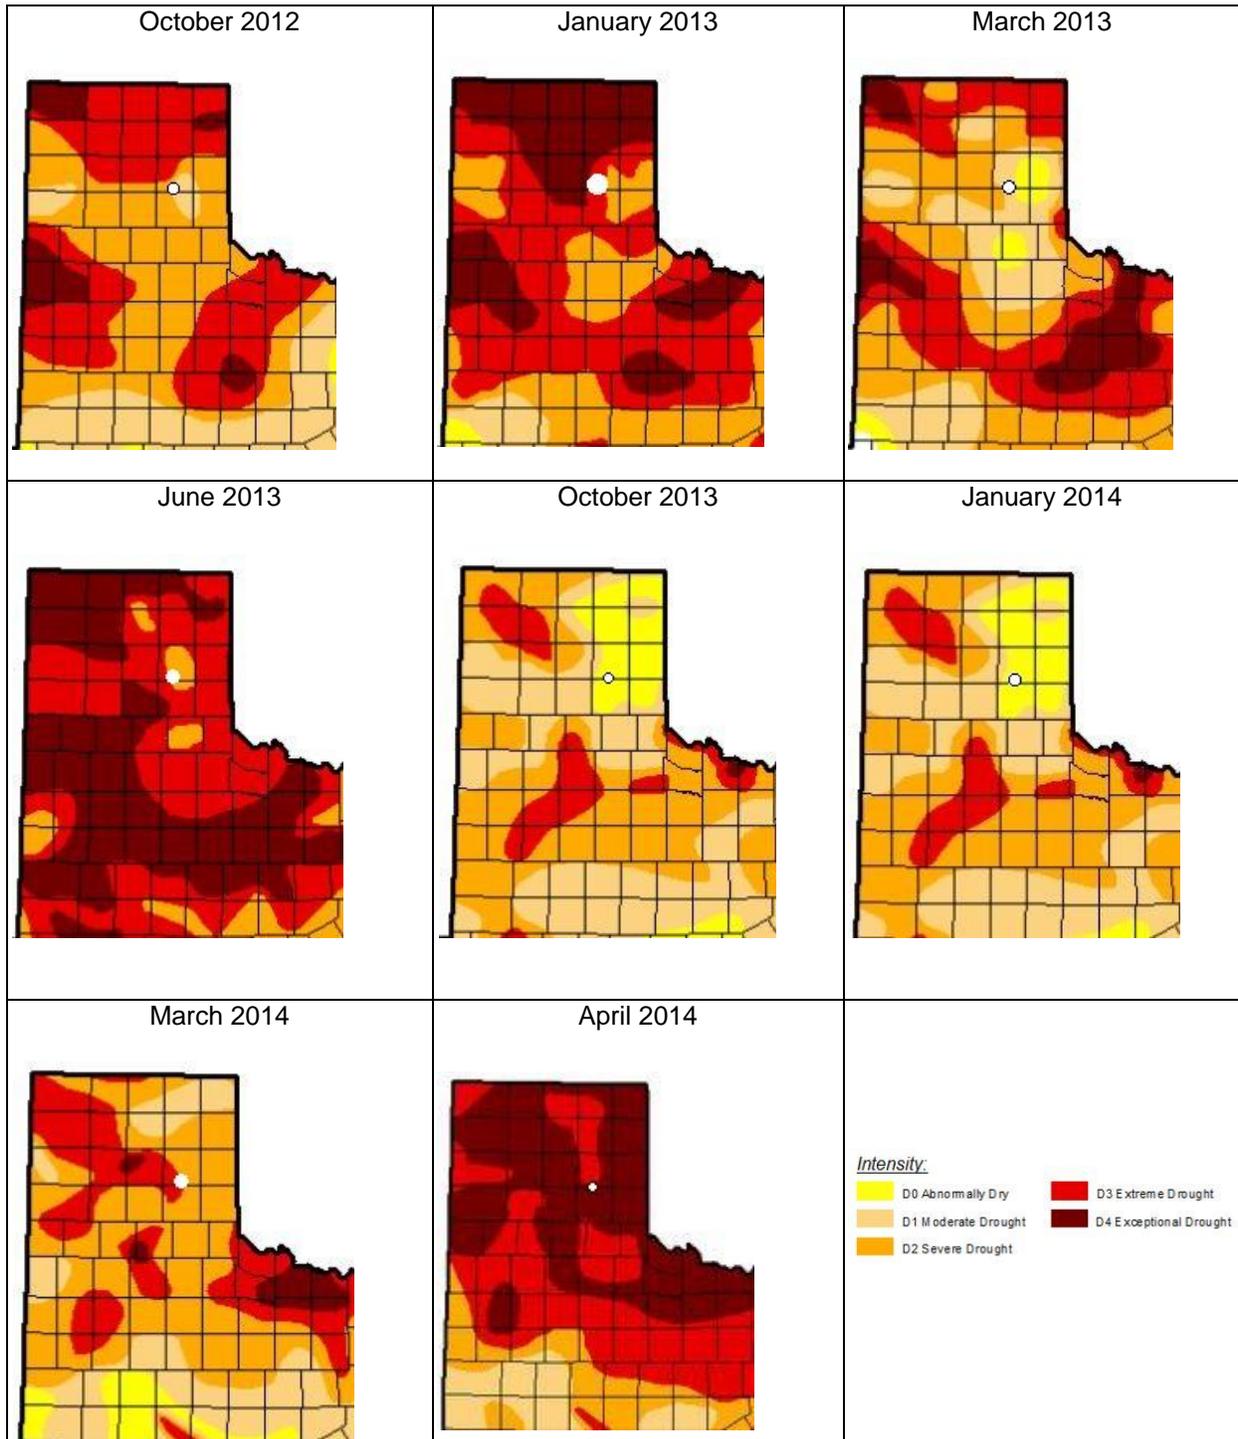
APPENDIX A

Recent maps of drought conditions in District 1A obtained from the United States Drought Monitor web site (<http://droughtmonitor.unl.edu/Home/StateDroughtMonitor.aspx?TX>). The white circle indicates the approximate location of McClellan Reservoir.

ISSUE 1: The current drought of record has caused the reservoir to go completely dry five times since 2000. Recent drought conditions are illustrated in Appendix A. The Climate Prediction Center predicts that the Pacific Decadal Oscillation will persist resulting in below-average precipitation in the Texas Panhandle for another 20 to 30 years. The current drought in the Texas Panhandle is forecast to persist at least through the end of the year with average to below average rainfall. Based on information from the National Oceanic and Atmospheric Climate Data web site (NOAA 2014) the reservoir watershed would need 4-8 inches of rainfall within a three-month period to end the current drought conditions.

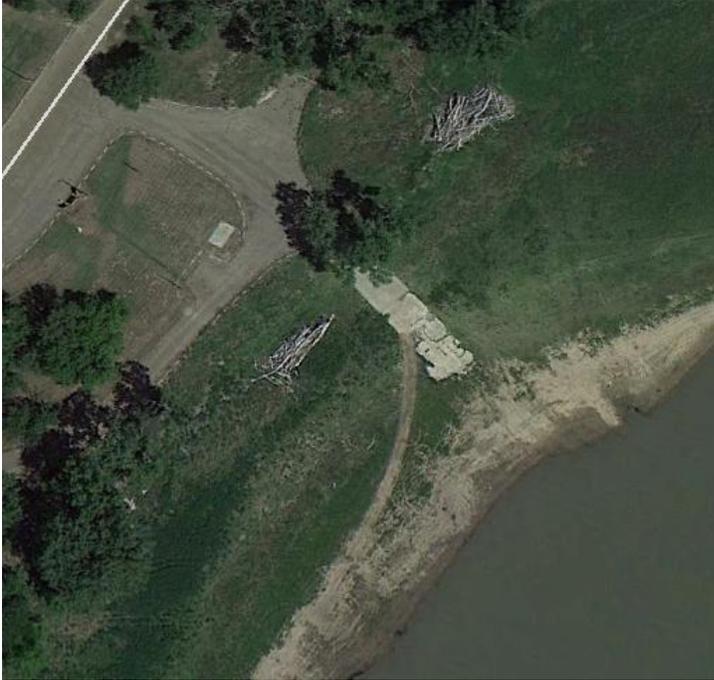
North Ramp

GoogleEarth satellite images of the boat ramps on McClellan Reservoir, Texas, imagery date 5/1/2012, accessed 3/5/14.

ISSUE 2: Boating access at the two public access sites (North Ramp and South Ramp) was not possible due to low water level in 2013. Neither boat ramp can be extended because the lake bottom levels out at the end of the ramp with no access to deeper water.

1. Since neither ramp can be extended, the basin has already been deepened, and the entire shoreline is accessible to bank anglers, there are no strategies for improving this situation.
