# Frio River Biology and Fluvial Geomorphology Study to Determine Impacts of Sand and Gravel Activity

River Studies Report No. 28

Inland Fisheries Division  
Texas Parks and Wildlife Department  
Austin, Texas

April 2019

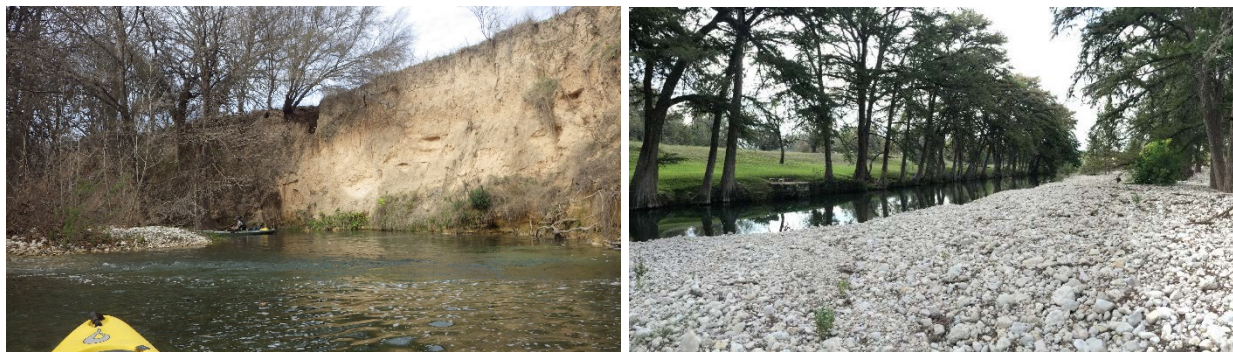
FIGURE 15.—Examples of dysfunctional riparian areas on the Frio River. The left photos shows extreme erosion that has led to the loss of some trees and a floodplain that is disconnected from the river. The right photo is located downstream from an area of past sand and gravel dredging and shows high levels of deposition of gravel which has degraded the riparian area on the right bank. The left bank shows a highly manicured riparian area.

In contrast, reaches that scored as limited or intermediate typically had large areas of riparian corridor with mostly unvegetated or highly manicured banks (Figure 15). These areas often showed signs of bank erosion, sometimes severe enough to cause loss of mature trees as a result of bank sloughing. These were often located in areas that were adjacent to road crossings that impeded sediment flow, were up- or downstream from former sand and gravel operations, or had ongoing heavy recreational use impacts (i.e. heavily trampled or continuously manicured by mowing/weed eating; Figure 16). One of the primary concerns in degraded riparian areas, especially in the case of highly manicured areas, is the loss of tree regeneration. As the mature trees eventually die of old age, there are no new seedlings establishing to take their place.

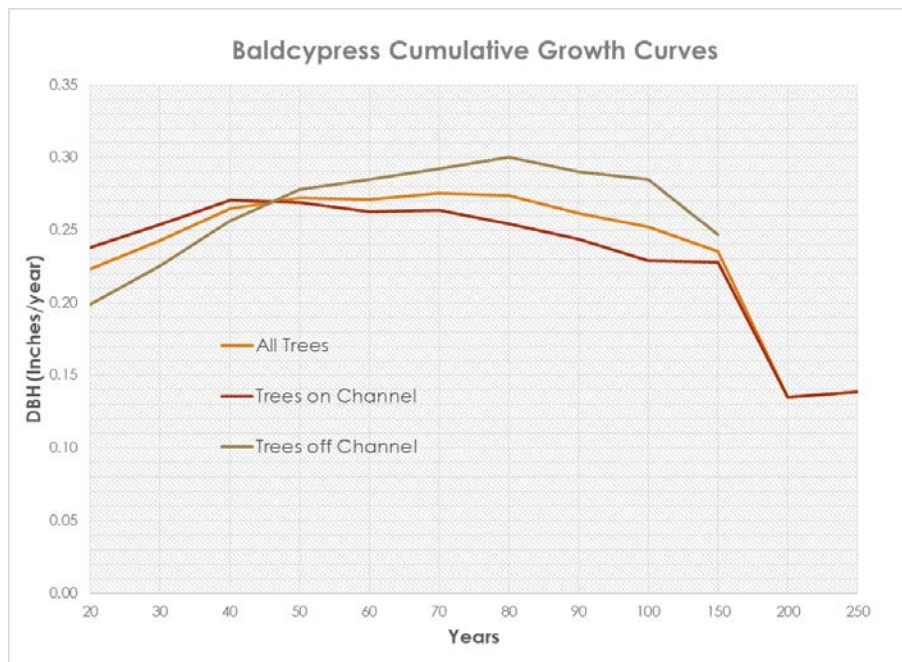
FIGURE 18.—Cumulative annual growth of all baldcypress (orange line), on channel trees (red line), and off channel trees (brown line) cored for this study on the Frio River in Real and Uvalde counties, Texas on July 19, 2018 (trees 1–11) and January 15, 2019 (trees 12–21).

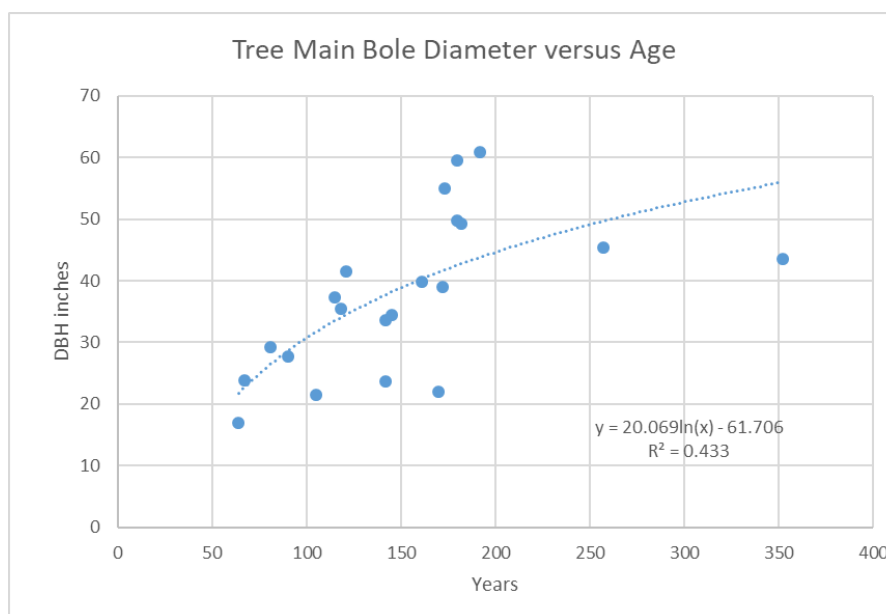
FIGURE 19.—Relationship between diameter at breast height (DBH) and age of baldcypress trees measured and cored as part of this study on the Frio River in Real and Uvalde counties, Texas on July 19, 2018 (trees 1–11) and January 15, 2019 (trees 12–21).

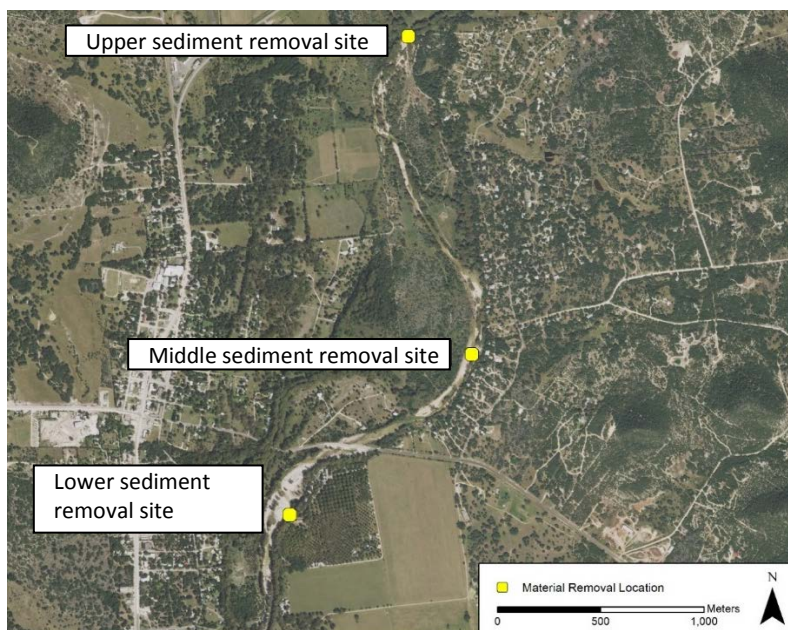
FIGURE 29.—Locations where sediment removal was modeled on the Frio River in Real County, Texas.

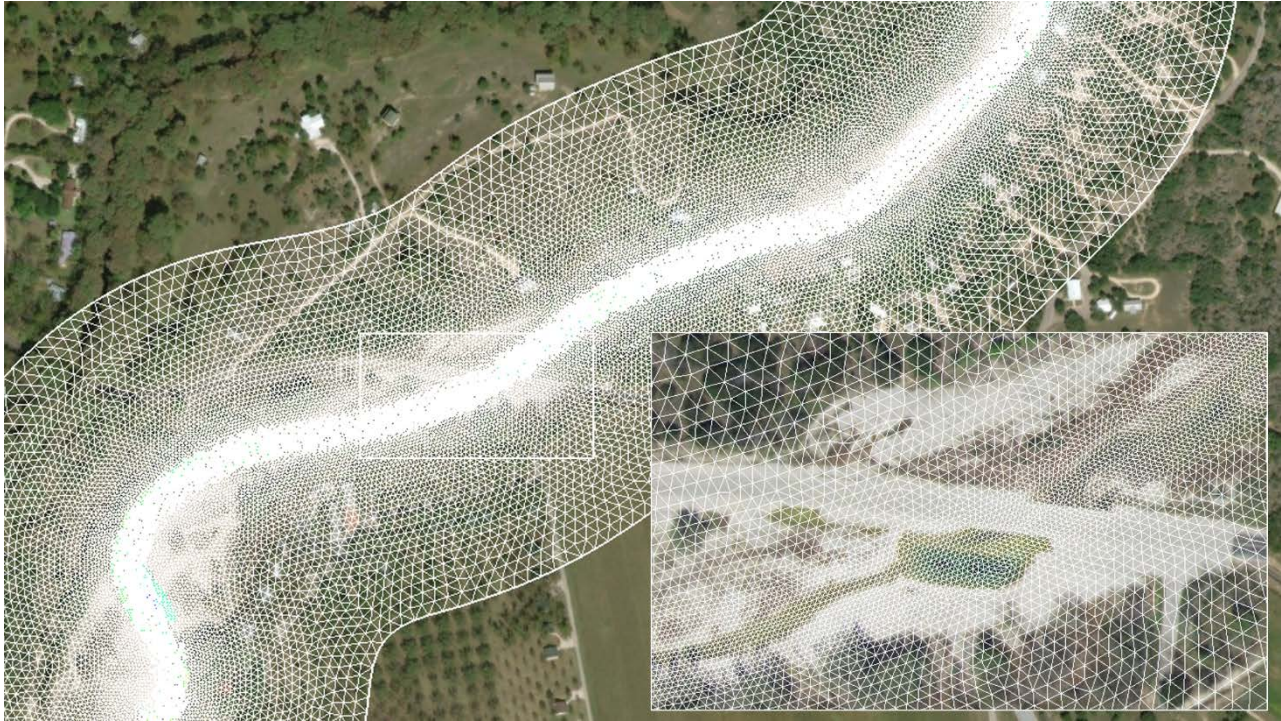
FIGURE F10.—AdH mesh on the Frio River near Leakey, Texas. Notice the greater number of computation nodes and elements closer to the center of the channel for higher resolution.

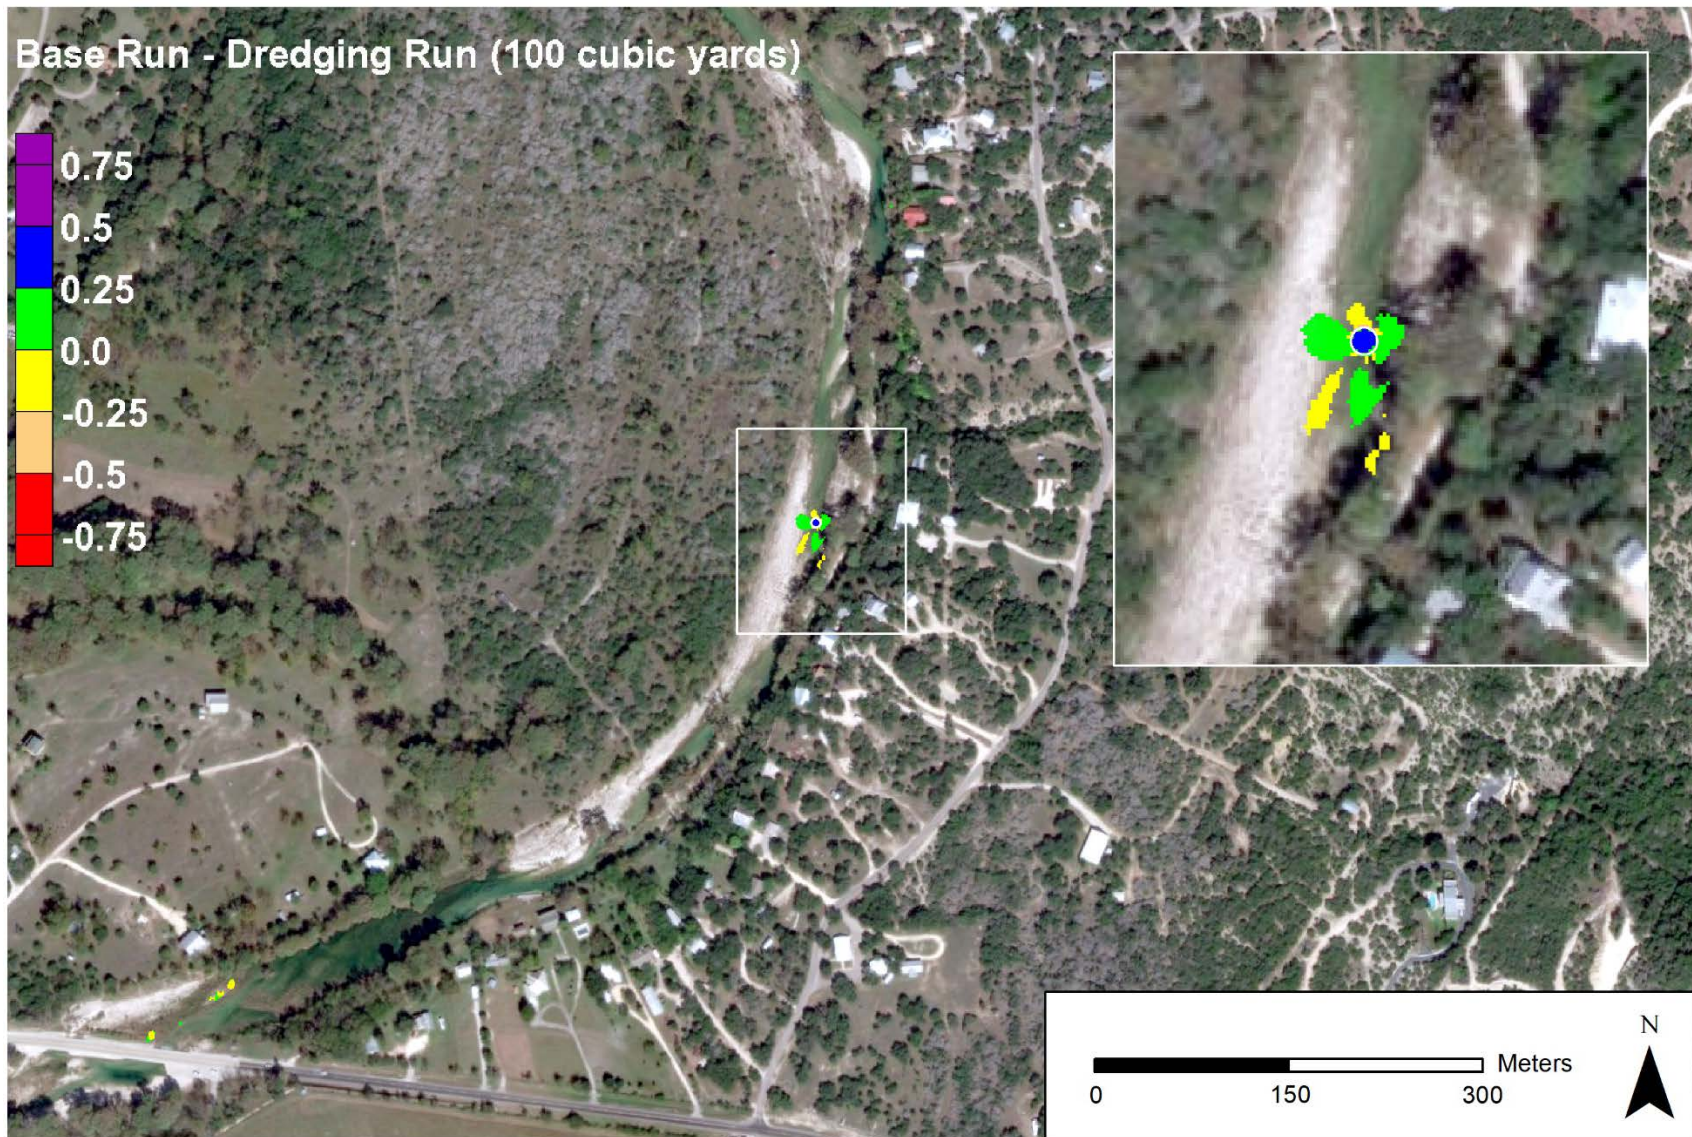
FIGURE F24.—This map shows the amount of change in deposition (relative to the base sediment model run, in meters) following removal of 100 cubic yards of material. Note the material removal site by the white circle.

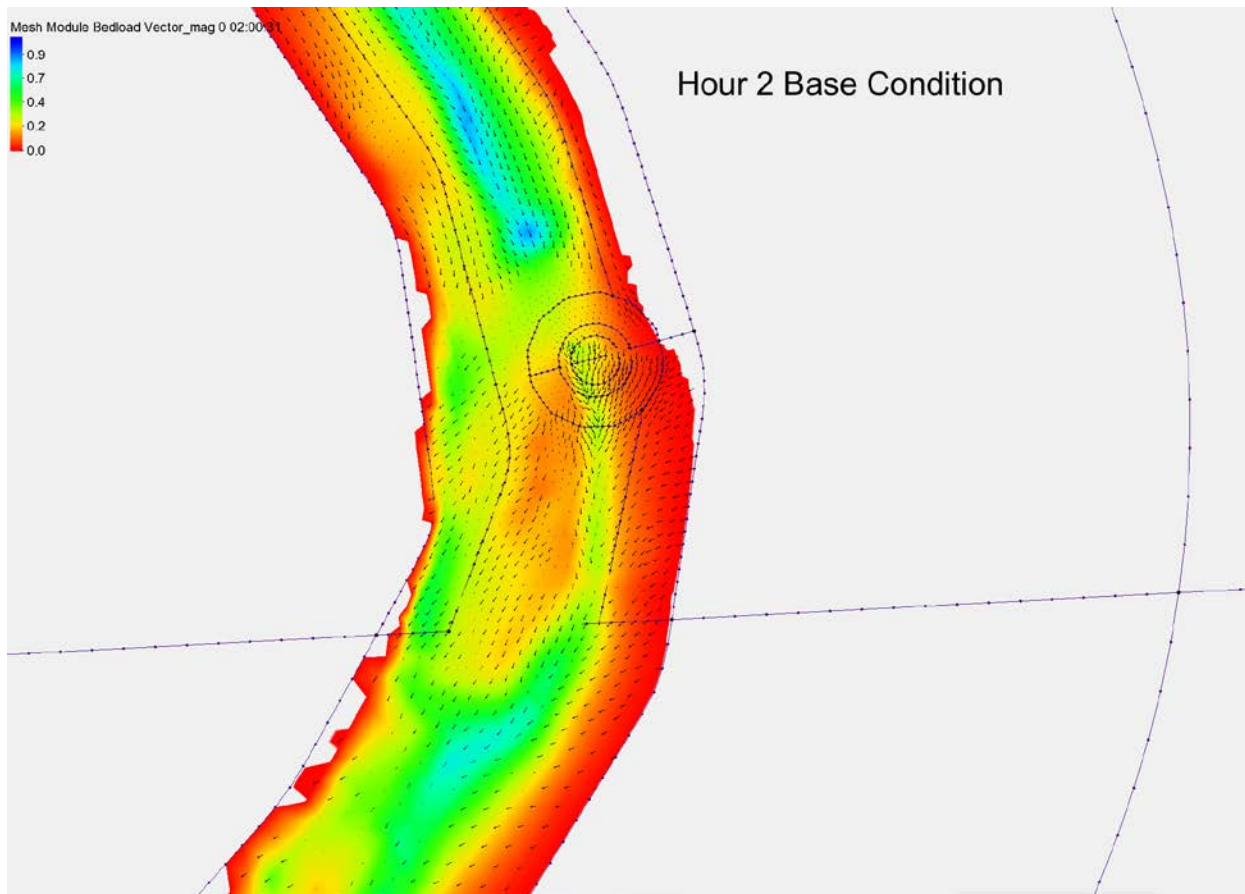
FIGURE F31.—Bedload magnitude in kilograms per second (Kg/sec) and bedload direction at hour 2 of the base sediment model run.

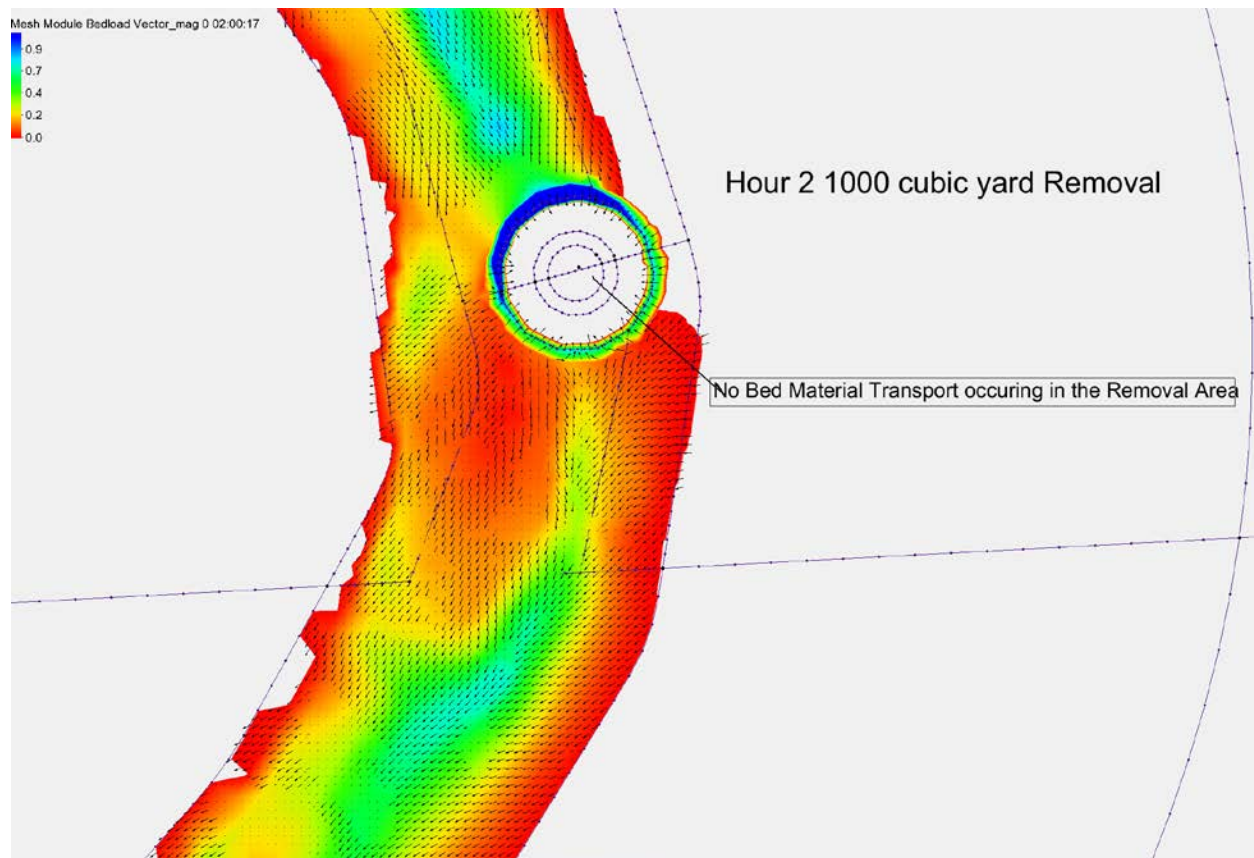
FIGURE F32.—Bedload magnitude in kilograms per second (Kg/sec) and bedload direction at hour 2 of the model scenario with 1,000 cubic yards of material removed.

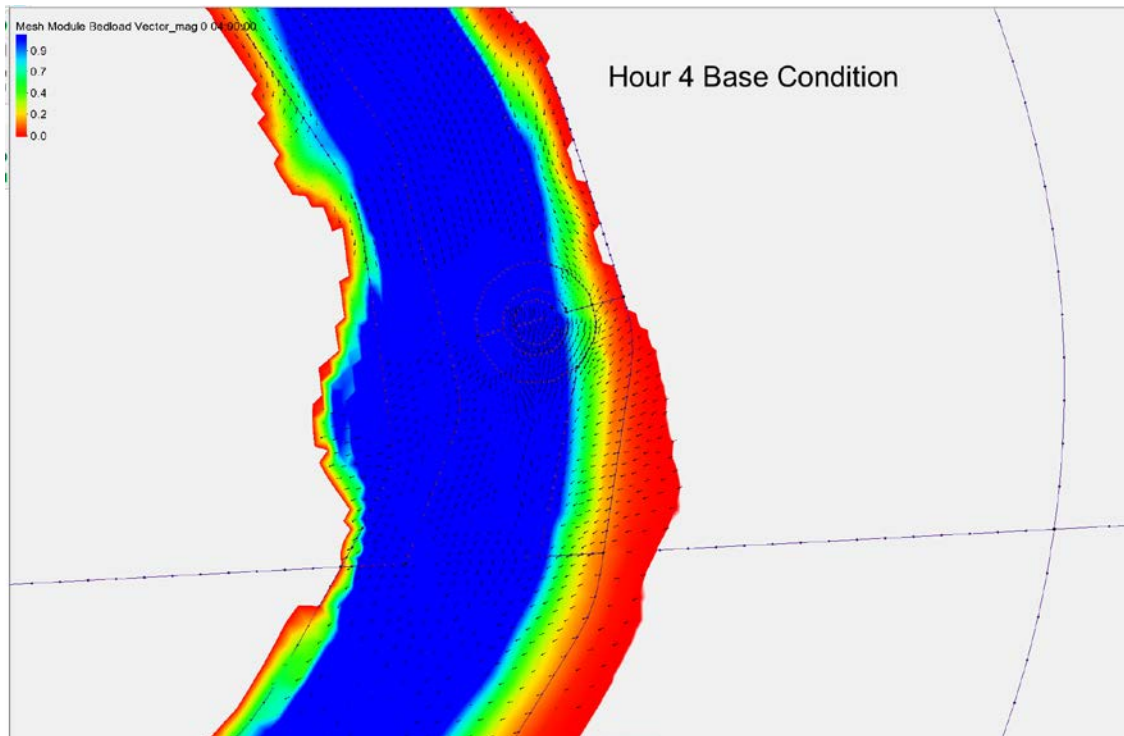
FIGURE F33.—Bedload magnitude in kilograms per second (Kg/sec) and bedload direction at hour 4 of the base sediment model run.
